GMC DENALI BRAKES

Installing Wilwood four-wheel disc brakes on a GMC Denali SUV

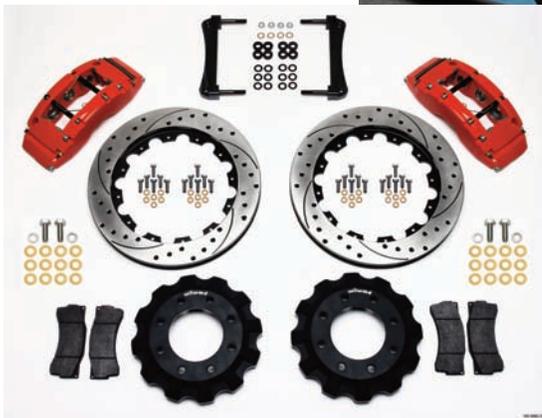
A big vehicle such as this Denali requires large brakes, so a Wilwood part number 140-8992 front disc brake kit was ordered. The kit features huge 16-inch vented and slotted rotors with aluminum hats, TC 6R six-piston calipers, caliper brackets, BP-10 Smart Pads, and all of the hardware required to complete the installation.

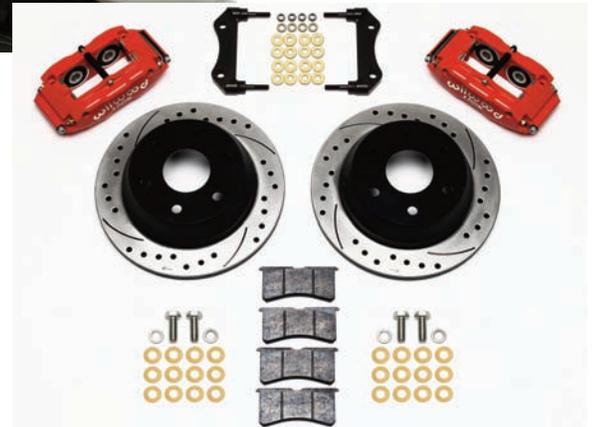
The Denali has an internal parking brake system so a Wilwood part number 140-8993 rear disc brake kit was ordered. The kit features 12.75-inch diameter drilled and slotted rotors with an internal parking brake drum, Superlite 4R calipers, caliper brackets, BP-10 Smart Pads and all of the hardware required to complete the installation.

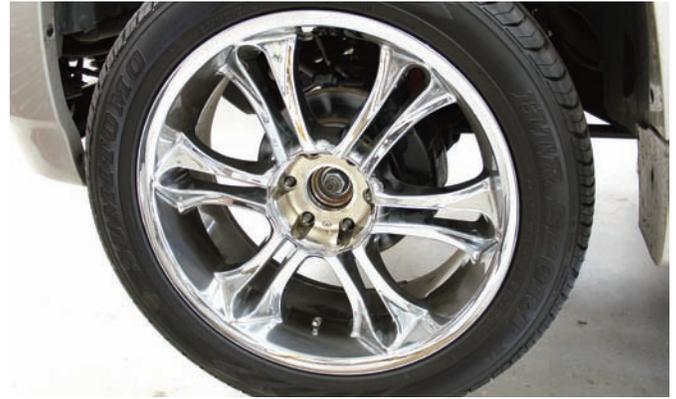
The Denali was raised up on a floor jack and then jack stands were installed underneath for safety. The hub-caps were removed and the lug nuts were disconnected with an impact gun and the correct size socket. After the lug nuts were disconnected, the large wheels and tires were removed.

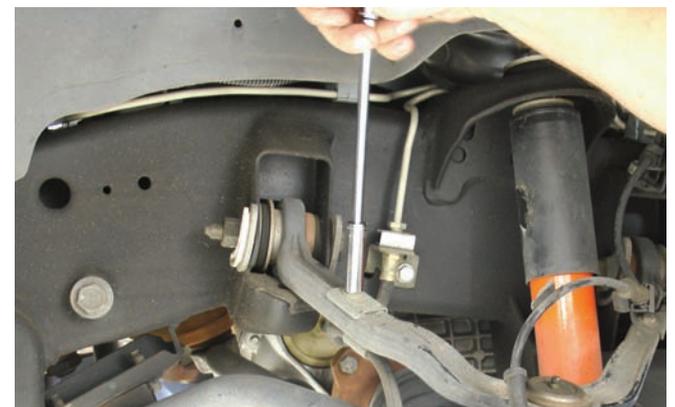
Before the rotor could be removed, the brake line brackets had to be disconnected. Here one of the small brackets was disconnected from the A-arm assembly. It is important to keep the brackets because they will be reused later.

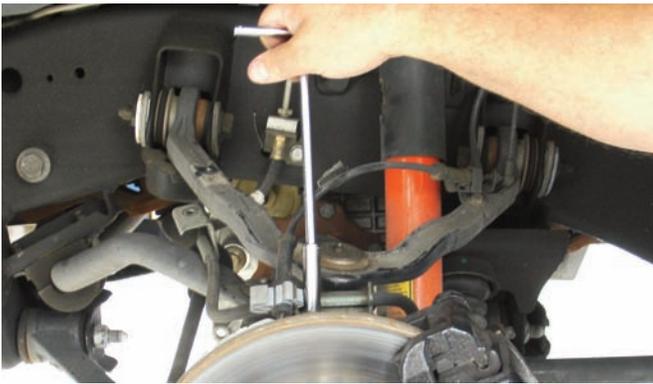
There is another hose bracket located on the top of the spindle. Using a T-handle and a small socket, the retaining bolt was disconnected from the spindle. This bracket will also be reused later.

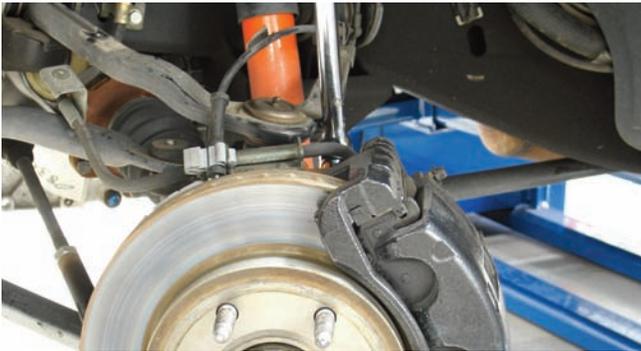
Using a ratchet wrench and the correct size socket, the Caliper bolts were removed from the original bracket assembly. A breaker bar may be necessary to break the bolts loose.

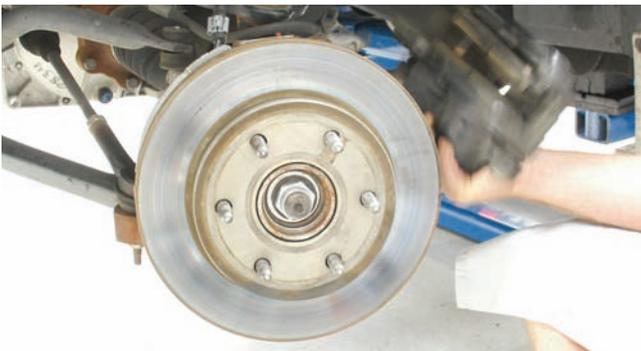
The caliper was lifted off of the rotor and was set to the side for now. It will be completely removed after the rubber line is disconnected from the steel line.

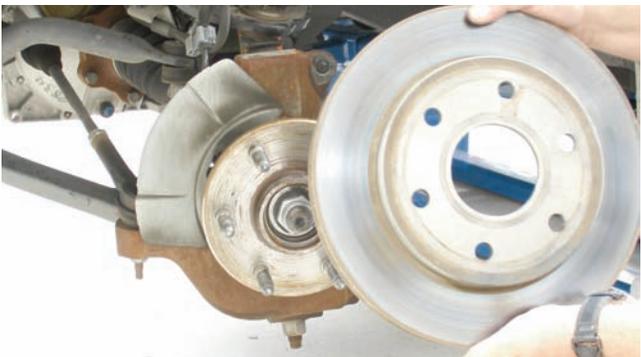
The rotor was lifted off of the hub assembly and was removed from the car.

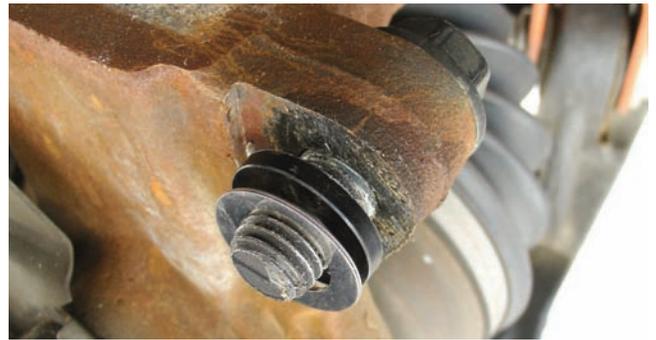
A M14-2.00 bolt outfitted with a M14 lock washer was placed through the hole in original caliper mounting ear and it was loaded with a 0.029-inch thick washer and a thin shim washer in preparation for mounting the caliper.

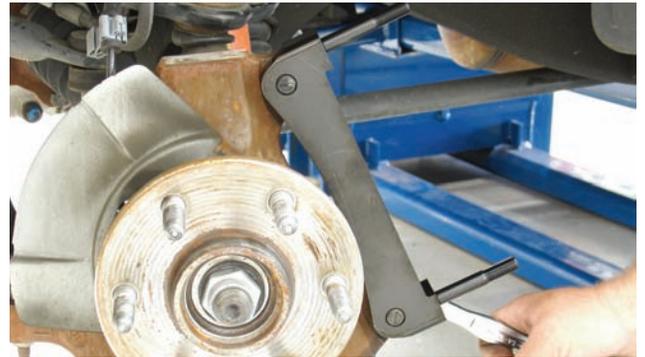
Here is the caliper mounting bracket after it was bolted to the original caliper mounting ears. Shims can be added between the bracket and mounting ears to center the caliper over the rotor.

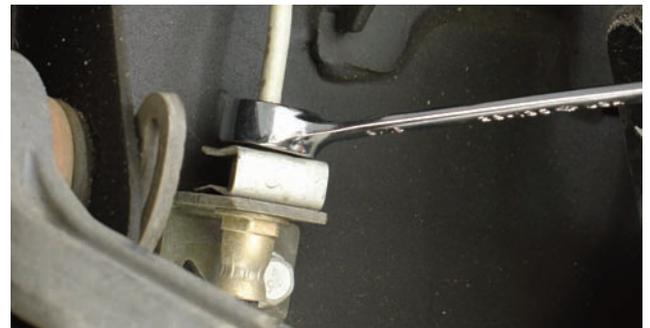
The hard brake line was removed from the rubber hose using a line wrench. The line was loosened but it wasn't removed yet.

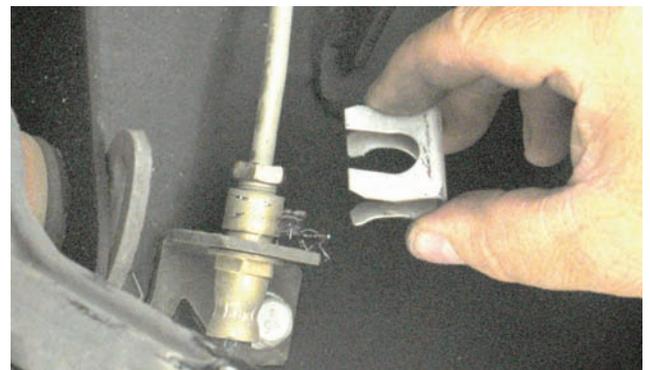
After the hard line was loosened from the rubber line, the spring clip retainer was removed.

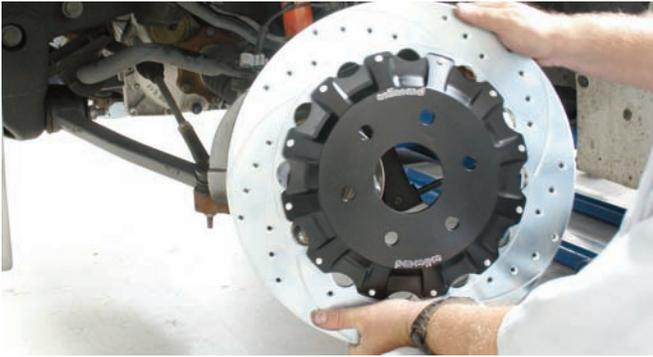
The aluminum hat assembly was bolted to the rotor using the bolts and washers in the kit. The small hub bolts were coated with Loctite 271 before the connection was made and then the bolts were tightened in an alternating pattern to 144 in-lbs using an inch-pound torque wrench. The bolts that were just installed were safety wired together.

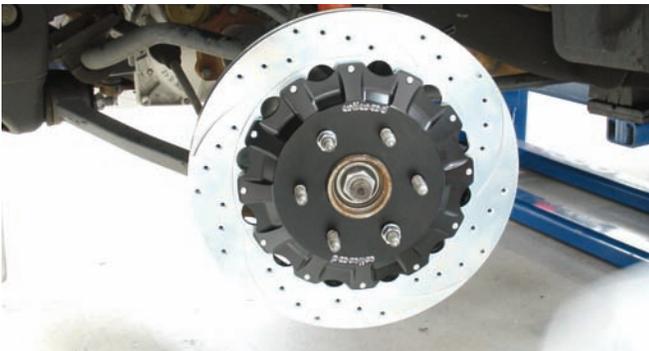
The assembled rotor was mounted on the hub assembly and then it was secured with two lug nuts.

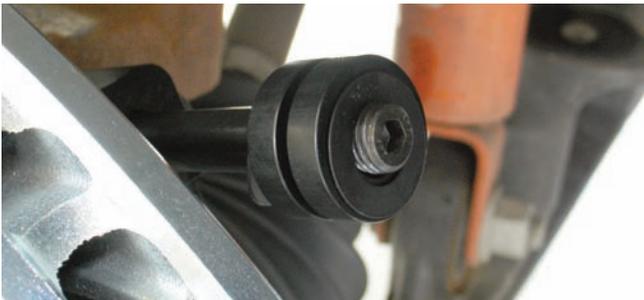
Before the caliper was mounted to the bracket assembly the studs were loaded with two spacers and a shim washer as seen here.

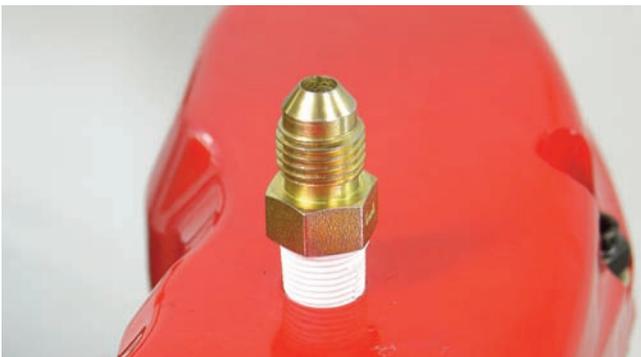
The caliper inlet fitting threads were wrapped with Teflon tape and then the fitting was screwed into the caliper body.

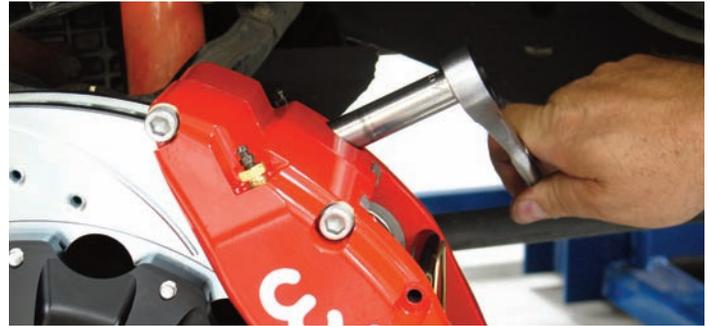
The caliper was placed on the bracket studs and then the washers were installed followed by the locknut. Here the nuts are being tightened in preparation for checking the caliper to rotor centering.

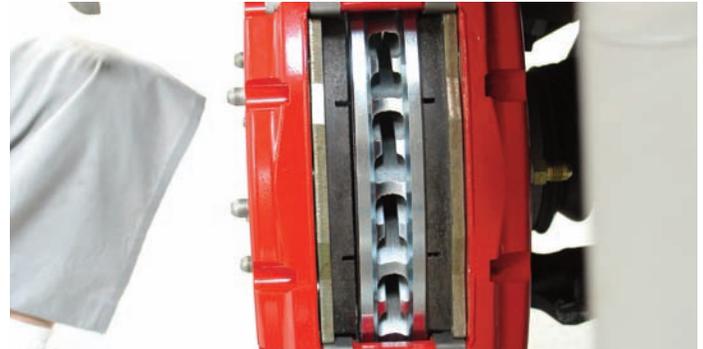
The caliper was centered and then the brake pads were installed. Here's a view of the caliper to rotor spacing after the brake pads were installed.

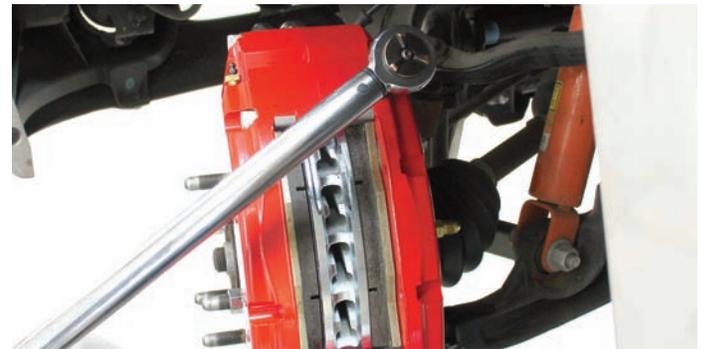
After the brake pads were properly installed and centered, the caliper nuts were tightened to 47 ft-lbs using a foot-pound torque wrench. The caliper bracket bolts were coated with Loctite 271 and they were tightened to 90 ft-lbs.

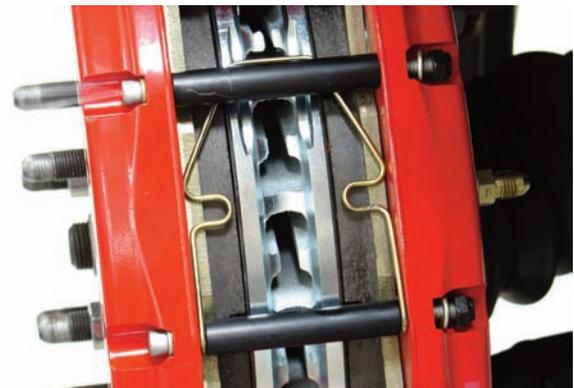
The two bridge bolts were installed along with the wire spring clip. The spring clip can be tricky to get in place.

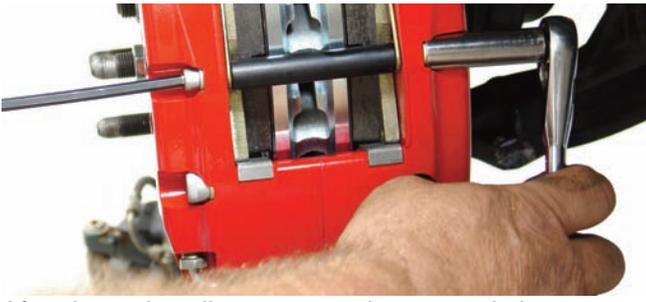
After the spring clip was properly mounted, the two bridge bolts can be tightened using a small socket wrench and an Allen T-handle.

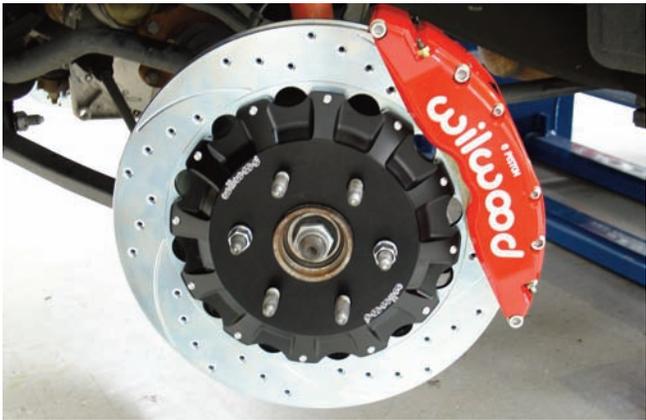
At this point the caliper and rotor are finished, but the brake lines still have to be hooked up. Looking at this system it is obvious that it will be far superior to the original brake system.

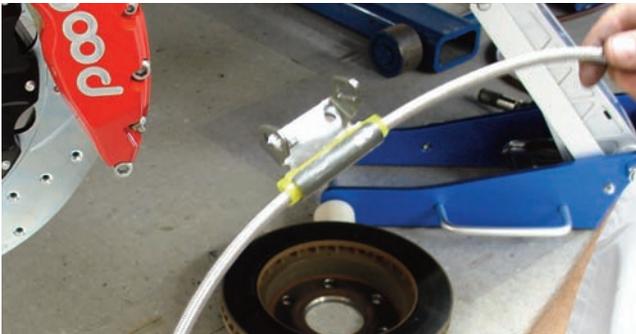
The hose brackets that were previously removed were reinstalled on the new Wilwood part number 220-8998 stainless steel braided line.

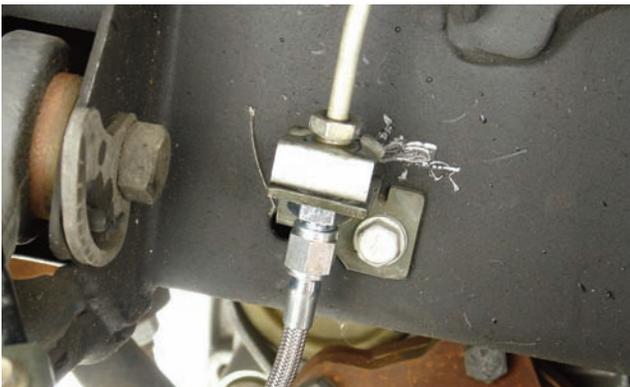
Using an adapter, the stainless steel braided line was hooked to the hard line and both were tightened to avoid leaks. The original clip retainer was reinstalled.

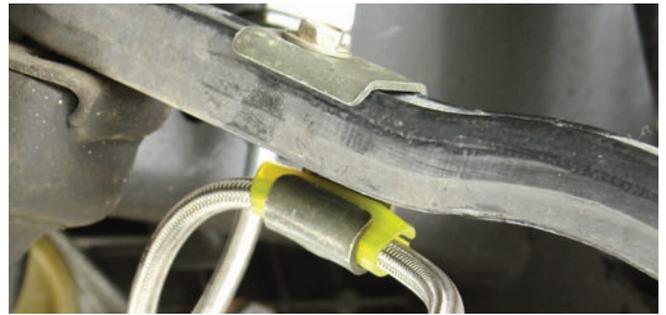
The hose clip was reused with the new braided line and was connected to the original mounting point on the A-arm. A small piece of plastic was installed between the bracket and line to protect it from damage.

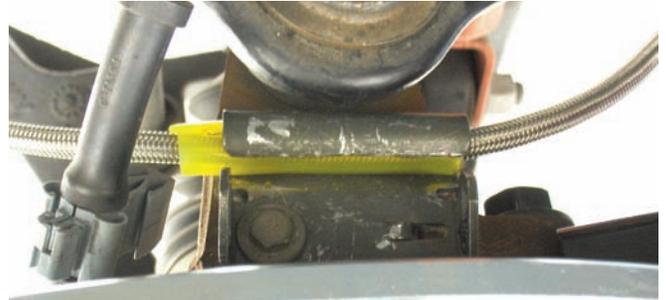
The other bracket was connected to the spindle assembly. The brackets were removed, spread apart enough to get the new hose and plastic protector inside and then the bracket was squeezed back together to secure the hose.

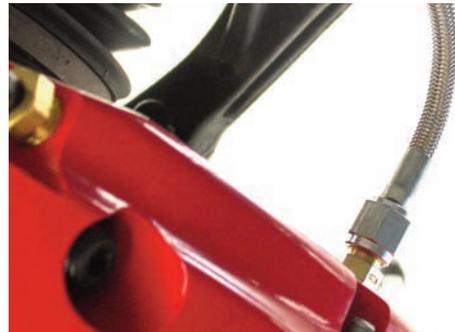
Here is the stainless steel line running to the caliper inlet fitting. It is important to make sure all of the connections are tight.

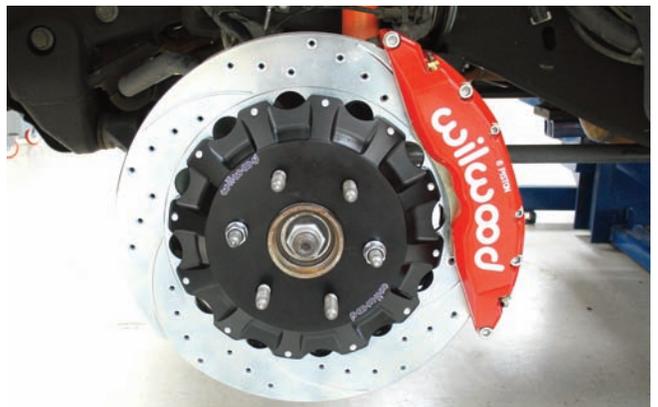
Here is the front brake system complete and ready to go. The brake system features the huge red TC 6R caliper and the 16-inch drilled and slotted rotor. The next step is installing the rear brakes.

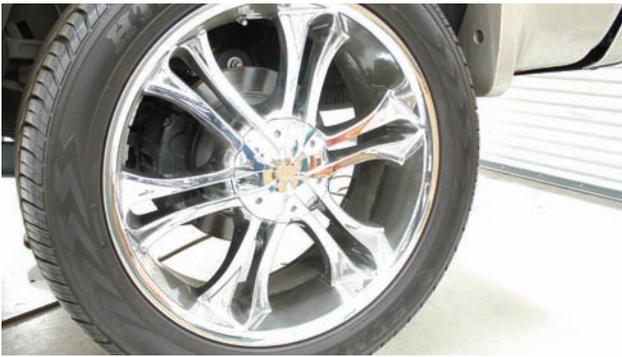
The front of the car was placed back on the ground and the rear was lifted and jack stands were placed underneath for safety. The hubcaps were removed and then the lug nuts were disconnected. After the lug nuts were disconnected the tires and wheels were removed.

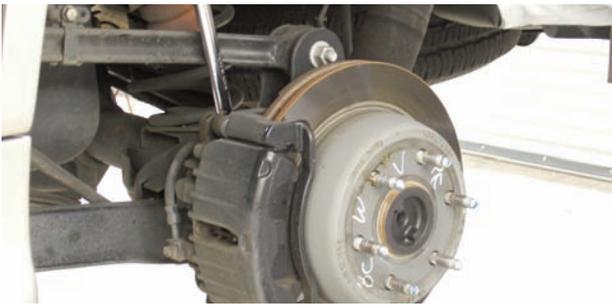
Using a breaker bar and the correct size socket, the caliper bolts were removed.

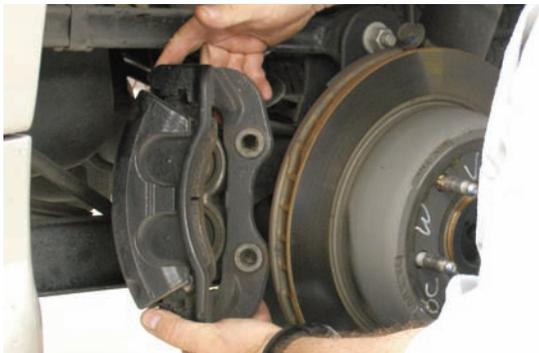
After the bolts were disconnected, the caliper could be removed from the bracket. For now the caliper was just moved out of the way while the new brakes were installed.

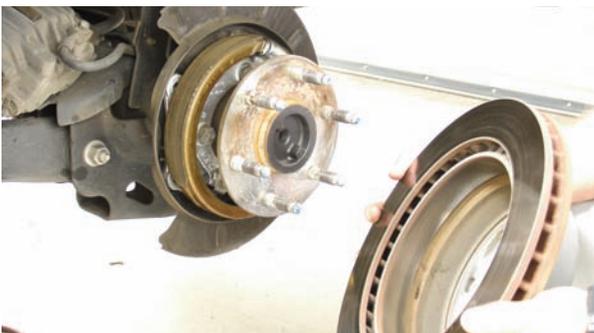
The heavy rotor was lifted off of the axle studs. You can see the original caliper in the background. It will be removed when the new lines are being installed.

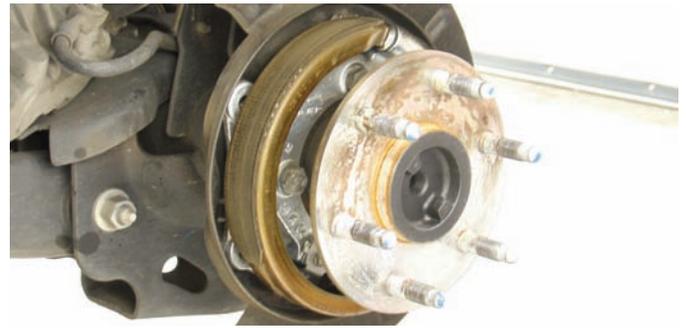
Here is a close look at the internal parking brake assembly. This is a useful assembly so it will be retained, which means the original parking brake cables remain intact.

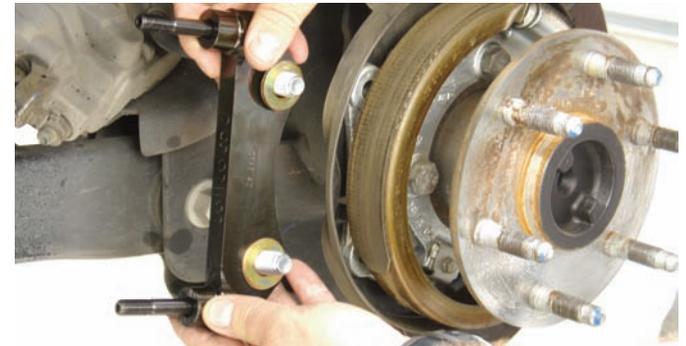
The caliper will be mounted to the original caliper mounting ears using a pair of M-14-2.00 x 40 mm bolts loaded with M14 I.D. x 21mm O.D. lock washers. After the bolts pass through the bracket they should be loaded with a 0.029-inch thick washer before the connection is made.

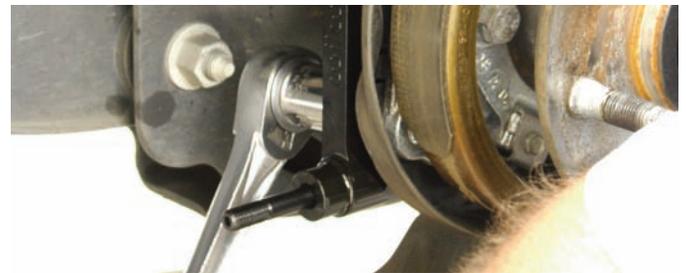
The bolts were installed finger tight and then they were tightened with a socket wrench to check the caliper to rotor centering.

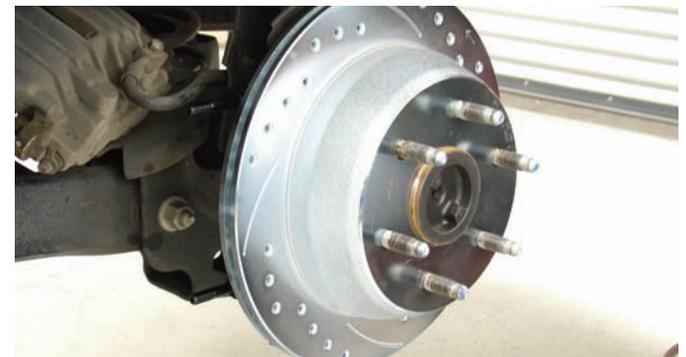
The Wilwood drilled and slotted rotor was installed on the axle flange and was pushed back to mount it on the centering ring. If you look close you can see the caliper bracket mounting studs in the background. This rotor has an internal drum assembly for the parking brake assembly.

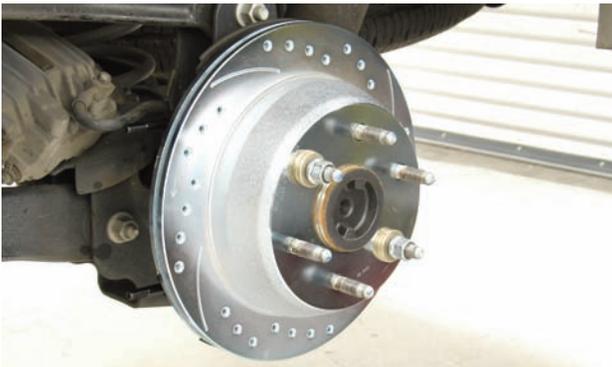
The rotor was connected to the axle assembly with two opposing lug nuts so the rotor to caliper centering could be done.

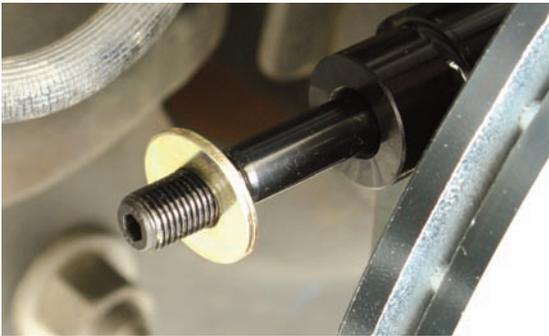
Before the caliper was installed, the caliper bracket studs were loaded with a 0.035-inch thick washer.

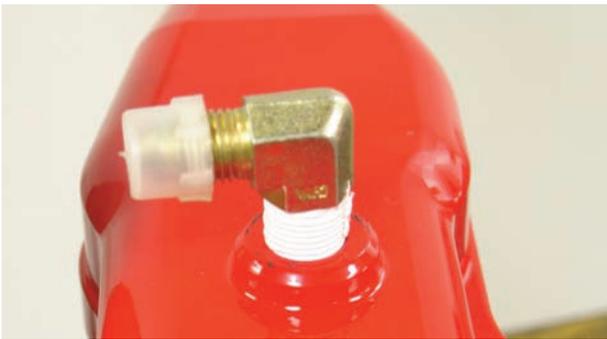
The caliper inlet fitting threads were wrapped with Teflon tape and then the fittings were screwed into the calipers.

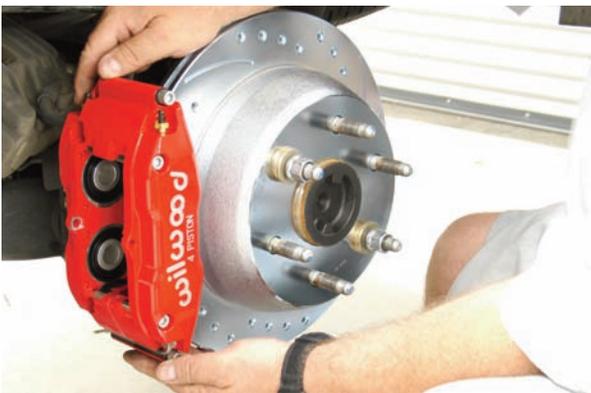
The large 4-piston Superlite caliper was installed over the studs. The bridge bolt was removed before the caliper was placed over the studs in preparation for installing the brake pads.

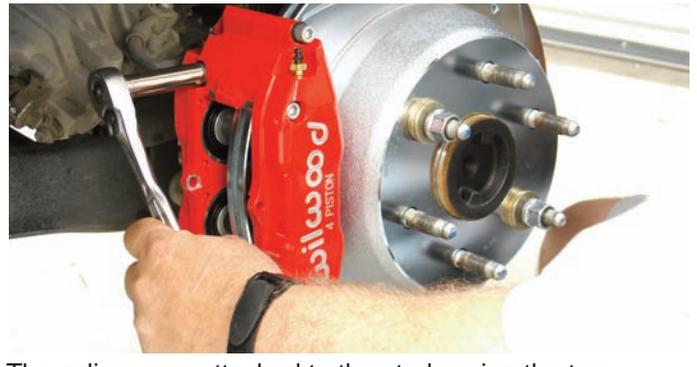
The caliper was attached to the studs using the two 0.057-inch thick washers and two self-locking hex head nuts. The rotor to centering should be checked and adjusted if necessary at this point. Shims between the caliper bracket and the original mounting ears can be used if necessary.

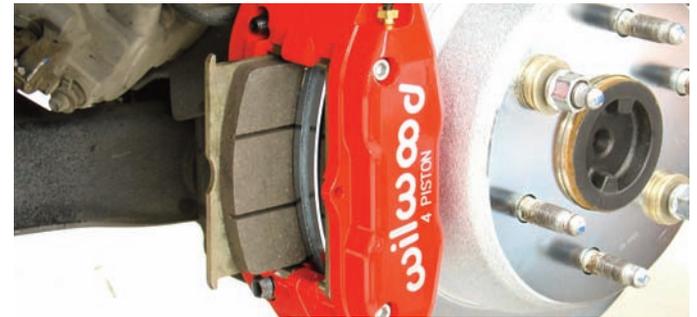
After the caliper was centered, the BP-10 brake pads were installed. The pads are designed for street performance use.

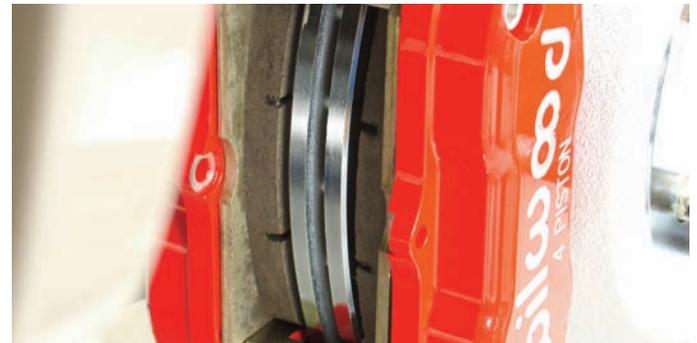
The brake pads are centered over the rotor and the radius of the brake pads match the radius of the rotors. At this point everything is looking good.

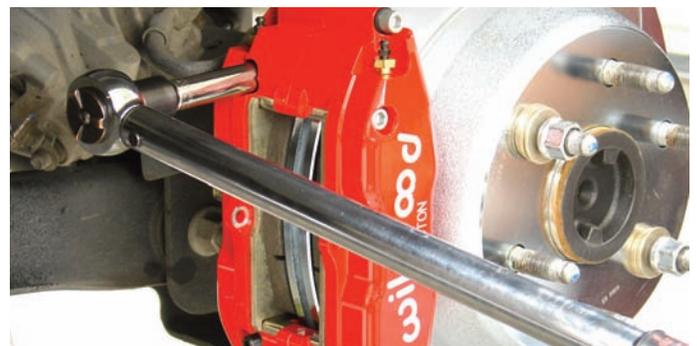
After the centering is correct and the radius of the pads match the rotor radius, the caliper mounting nuts were tightened to 35 ft-lbs using a foot-pound torque wrench.

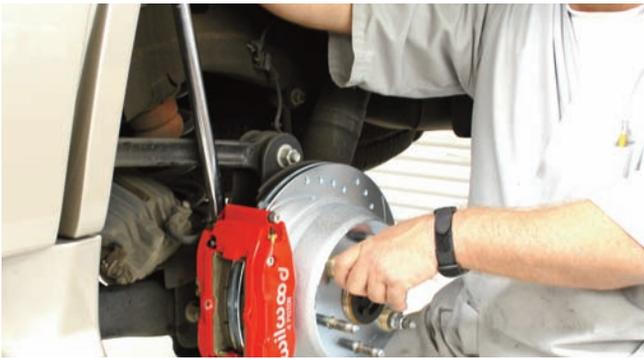
Now the caliper mounting bracket bolts were tightened to 90 ft-lbs using a foot-pound torque wrench.

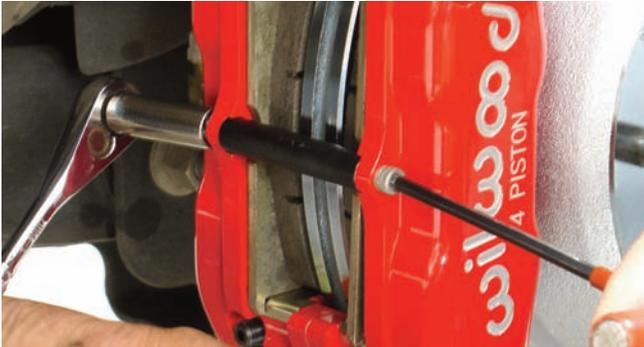
The caliper center bridge pad retainer bolt was re-installed and it was tightened with a small socket wrench and a T-handle.

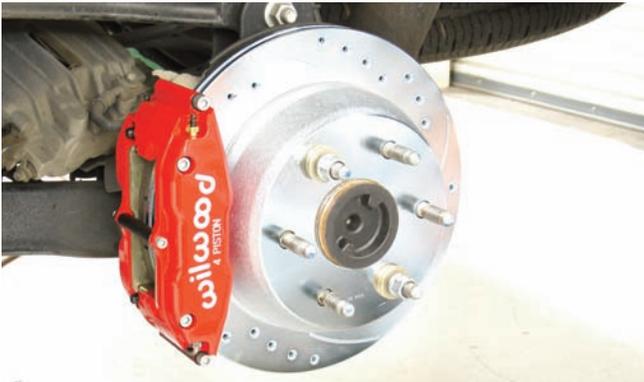
Here is the finished brake assembly featuring the red Superlite four-piston caliper and the drilled and slotted rotor.

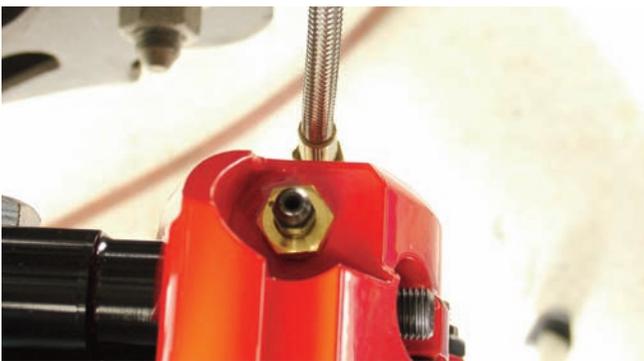
The hose connection was made from the caliper to the hard line. At this point the old caliper can be removed. The brake system will require bleeding and the pads will have to be bedded in.

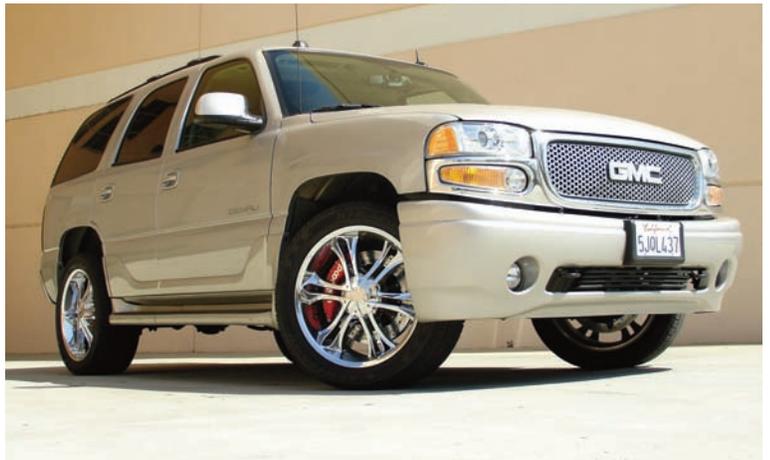
The Denali looks terrific with the large diameter wheel and low profile tires. The brakes add to the truck appearance and it stops better than ever.
